# HISTORICALLY SIGNIFICANT ARCHITECTURE IN AMES

DEPARTMENT OF  
COMMUNITY DEVELOPMENT  
CITY OF AMES

This book is a compilation and summary of data gathered by the Central Iowa Regional Association of Local Governments (CIRALG) in conjunction with the Iowa Division of Historic Preservation.

It contains the results of a survey conducted in 1979 of architecturally significant buildings in Ames. Similar surveys were conducted throughout the eight county CIRALG area, with 125 communities being canvassed.

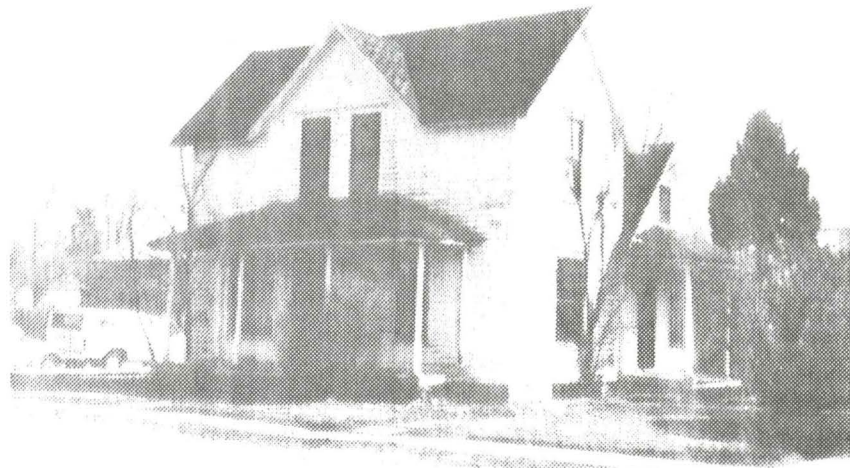
**STREET ADDRESS:** 622 Burnett Avenue

**THREATS TO STRUCTURE:** roof needs repair

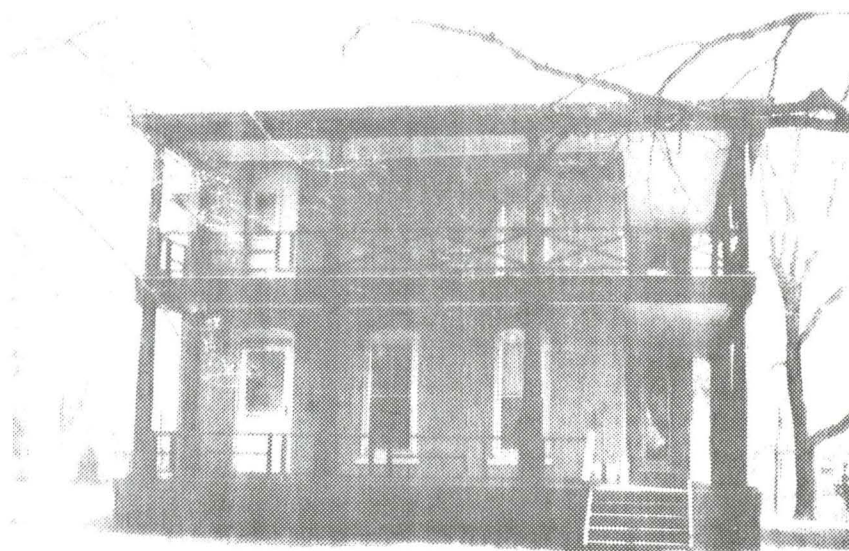
**STREET ADDRESS:** 522 Carroll  
**ORIGINAL USE:** Residence  
**PRESENT USE:** Residence (apartments)

**THREATS TO STRUCTURE:** gutter & eave in some need of repair

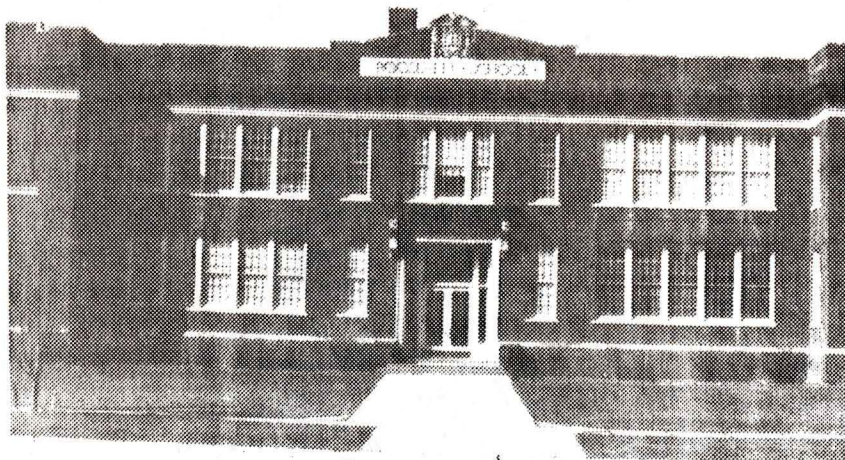
**STREET ADDRESS:** 921 - 9th Street  
**ORIGINAL USE:** Public school  
**PRESENT USE:** Public school

**THREATS TO STRUCTURE:** brick parapet and some sections of wall show stress cracks.
